## From military training area to National Park over 20 years: Indicators for outcome evaluation in a large-scale restoration project in alpine Norway

The aim of this paper is to present and discuss the process and outcome from the restoration of the Hjerkins military training area at Dovrefjell as a demonstration site for large-scale landscape restoration. We will demonstrate the restoration cycle from the initial Parliament Decision, through planning and implementation phases, and the final outcomes. Further, we describe how the project performed in linking overall restoration goals with specific targets, developing a set of indicators to evaluate restoration outcome at different spatial and temporal scales, and combining generalised and subjective indicators for overall project evaluation. Finally, we tie the final outcomes back to the initial overall goals for the project, and identify lessons learned (challenges, pitfalls, and successes) that can be communicated into future projects. Special attention is given to the development of solutions for large-scale implementation of restoration in the field, and how these relate to the *upscaling and integration*, as prescribed by IP

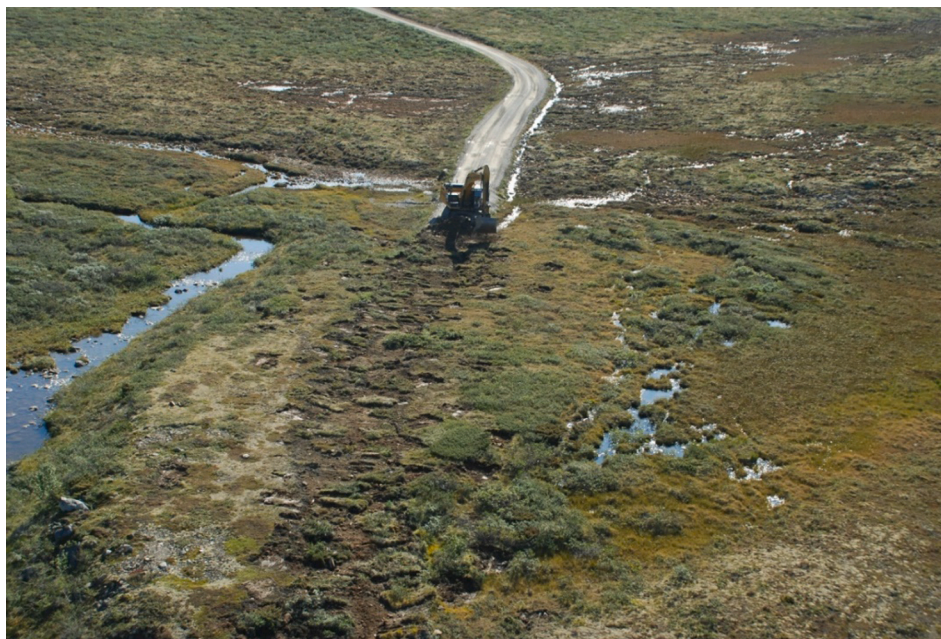
Fig. 3. Standard method to remove roads included removing added gravel, reshaping original terrain surface and transplanting turfs from road verges to wipe out the artificial borders and promote vegetation recovery.

The standard method for removing roads, that was developed during the project (see chapter 5.2.4), was to wipe out the border between the original landscape and roads by removing construction gravel and subterrain tubes (made of plastic, concrete, or metal), aiming for restoring original mass balance, reshaping the original terrain and wetland structures (Fig. 3). Vegetation turfs were transplanted from road verges within the range of an excavator, into the affected area to facilitate vegetation recovery. A systematic procedure was developed in cooperation with the excavator personnel, to prevent any new damage to adjacent vegetation when digging the turfs; restrict size of turfs, squeeze the hollow after digging, density of turfs (see Hagen & Evju 2013 for further details). Larger constructed areas, such as the ammunition testing fields (Fig. 4a) and demolition sites, were tilled by stirring (Fig. 4b), so that the original soils that were built upon, were moved to the upper surface. The 'new' surface was then shaped according to nearby terrain. In drained or filled wetland areas, such as peatland and freshwater habitats, the drainage tubes were dug out, and the construction gravel removed down to the original water level, with the purpose of restoring original hydrological structures and drainage.

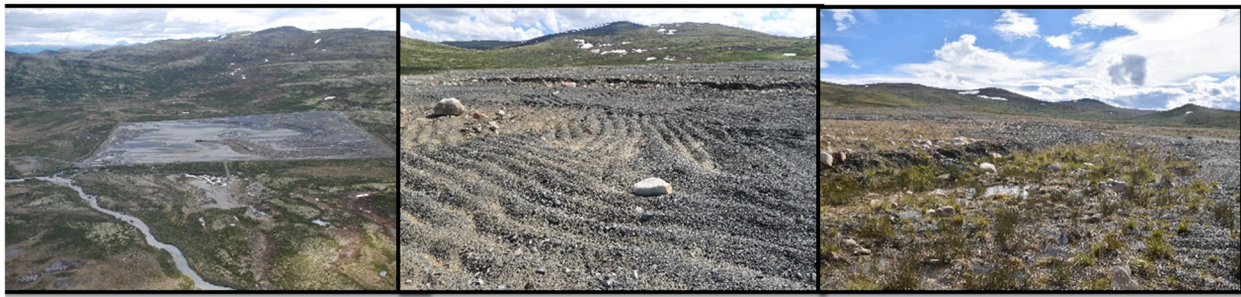
**Fig. 4.** a) Restoration of a 600 × 400 m large homogenous testing field included land shaping in 2013, b) tilling of surface soil in 2013, c) seeding of native *Festuca ovina* and planting of local willow-species (*Salix glauca*, *S. lapponum* and *S. phylicifolia*) in 2014 to improve conditions for long term vegetation recovery, as observed in 2020.

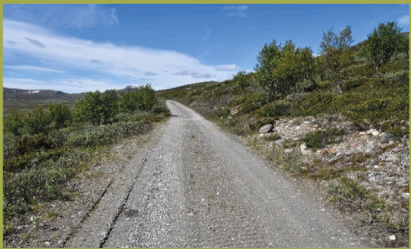
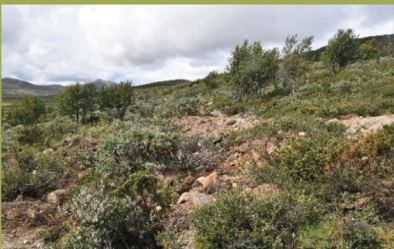
<p><i>Grisungdalen (site 17)</i></p> <p><i>Very satisfactory</i></p>

**Fig. 8.** Expert evaluations (Table 2) assigned each restored site into one of four main classes, as illustrated by selected sites before (left) and after (right) restoration. Dark green: Military road Grisungdalen. Light green: Military road Piloten. Yellow: Ammunition testing field HFK-plain. Red: Gravel pit M2 Storranden. Deviation from ‘very satisfactory’ is described in the Evaluation column. (For interpretation of the references to colour in this figure legend, the reader is referred to the web version of this article.)

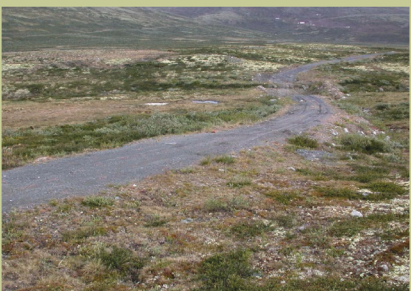
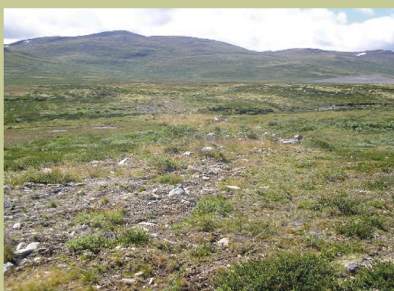
<p><i>Piloten (site 21)</i></p> <p><i>Satisfactory (terrain not completely reshaped – gravel surplus)</i></p>

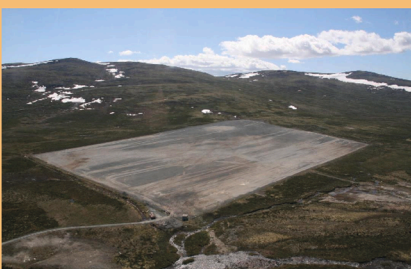
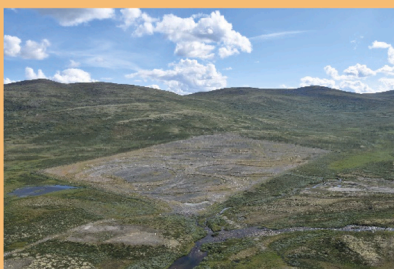
<p><i>Ammunition testing field, HFK-plain</i></p> <p><i>Partly satisfactory (terrain not reshaped, surface only partly tilled)</i></p>

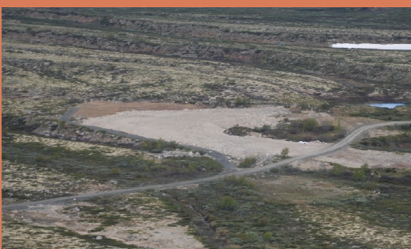
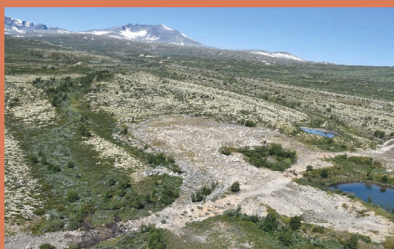
<p><i>Gravel pit M2 Storranden (site 10)</i></p> <p><i>Not satisfactory (landscape recovery not performed)</i></p>

The expert evaluation of restored sites (Table 2) showed that the output was generally good (more satisfactory) for site categories with several sites represented, such as military roads and slip roads, although exceptions occurred. In sites with partly satisfactory or not satisfactory output, experts explained that this could be accounted for by challenging *natural conditions* (e.g., very coarse soils or complex landscape types), *previous decisions* (i.e., decisions taken early in the project restricted the later actions) or *early decisions* (lack of experience during restoration early in the implementation phase), or *compromises* between time and quality (e.g., premature decisions). Diverging evaluation between experts (two or more classes distance) were not specifically linked to any of these explanations, though the site with most diverging evaluation (Gravel pit M1, Table 2) had complicated natural conditions in combination with time/quality compromises during implementation.

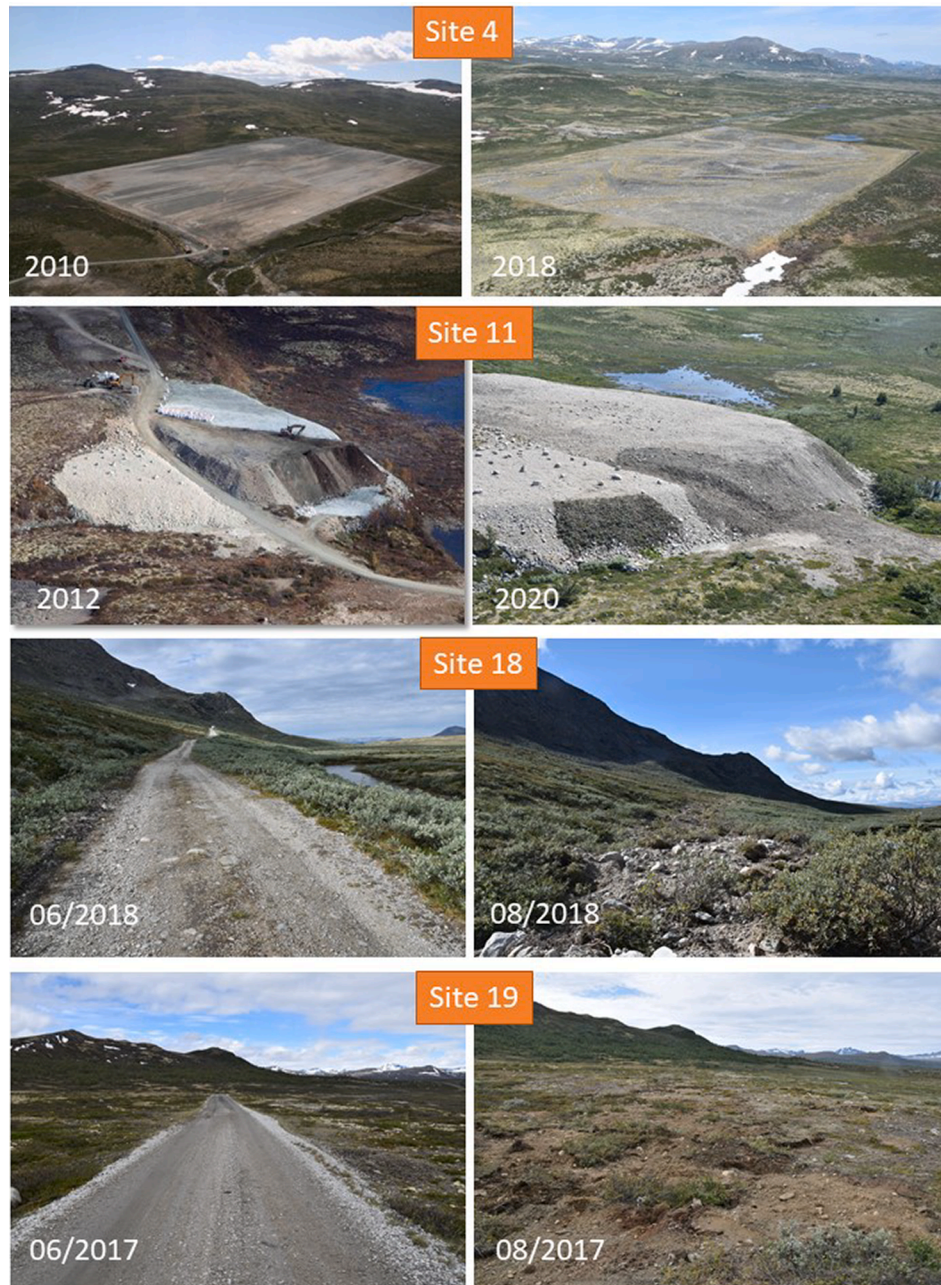
## Appendix C

Before- and after-picture of selected sites (number according to Table 2) in Hjerkinn military training area, including time when pictures were taken.
